EPA Region 10
PCB Compliance Inspection Report

Facility Name: Rainier Commons, LLC

Inspection Date: March 24, 2009

Description of PCB Inspection

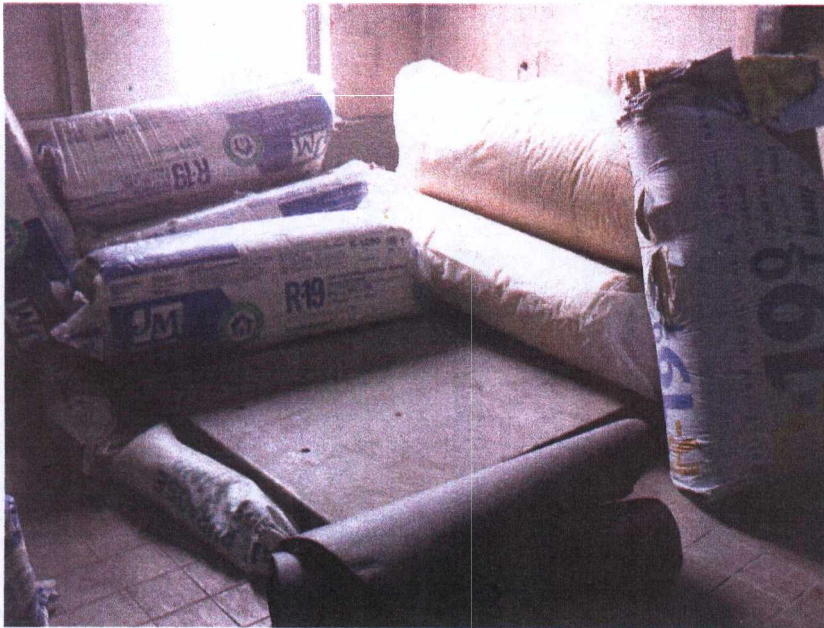
Photo No: P1000860

Description: Former location of a pad mount transformer inside Building 5 on Floor 400. The Farallon Report dated April 2004 stated there were leaking transformers at the Brewery, but did not identify the location of the leaking transformers. There was no visible evidence there had been any leaking transformer oil on this concrete surface.

In Building 5 on the fourth floor (Noted as Floor 400) was a raised concrete pad, which is believed to be a former location for a transformer (Photograph No. P1000860). The materials stored on the pad were removed and I saw no sign of oil stains or any decolonization to the concrete. Mr. Alon said to me, the transformer had to have been removed long before Rainier Commons purchased the property.

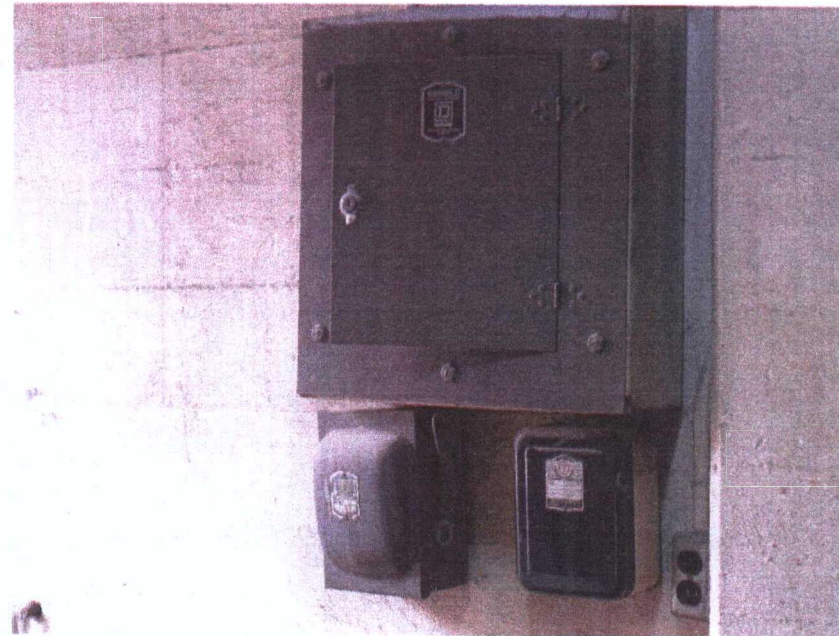
Description: Electrical switches on the wall near the former transformer pad inside Building 5 on Floor 400. All were dry and no visual evidence of leaking oil, present or in the past.

There were some electrical switches and a fuse box on the wall in Building 5 (Photograph No. P1000862 and P1000864). These articles were not oil filled and there was no leaking potting compound from these articles.

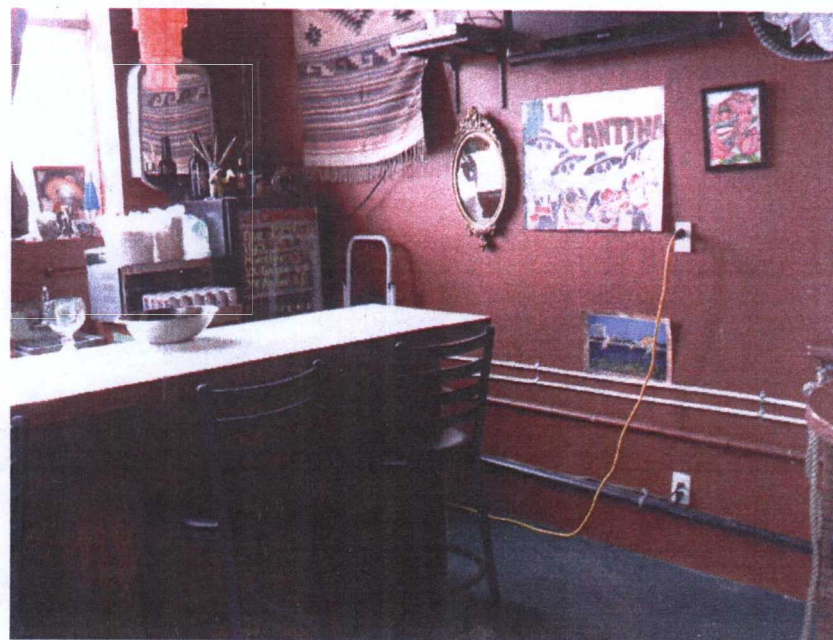
Description: The northwest corner of Building 25 is a food a d drink establishment. The north end of the bar is a former location of a transformer. The floor of the bar has been recovered and the walls painted. There is no sign of past oil leaks from equipment that may have been previously located in the room.

In Building 25 on the third floor is a restaurant and bar. The corner where a former transformer was in use is now a bar and the location of a refrigerator used to store beer (Photograph No. P1000868).

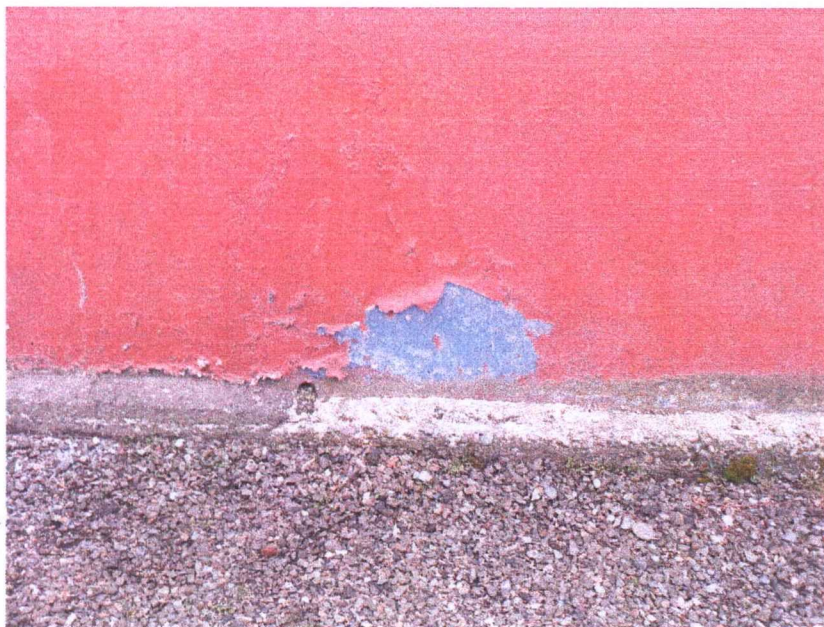
Photo No: P1000870

Description: In the Vernon Environmental Report date June 2006 it was identified to Rainier Commons that the old brewery buildings contained PCBs at concentration greater than 2000 mg/kg. EPA collected a sample of the paint from the west wall of Building 13 (Sample No. 09124301). The results of the analysis shows PCBs in the paint greater than 2000 mg/kg.

During this inspection, I collected paint samples from the exterior wall of Building 13. This wall faces west and parallel with Airport Way. I also gathered paint chips that had accumulated in a gravel strip between Building 13 and the parking lot. This second sample also includes paint chips that had migrated to the edge of Catch Basin 2 (Attachment I, Page 5). Table II summarizes the PCB results for the two Paint chip samples I collected on March 24, 2009.

Mr. Alon said to me that his company had cleaned the building in 2005 and painted over the PCB paint to try and encapsulate it. Mr. Alon said his company is planning to do a cleaning of the exterior walls later this year (2009) and try to encapsulate the PCB paint to prevent it from continuing to peel off the building. I advised Mr. Alon that before he did this, he would need to contact EPA for approval. Rainier Commons has known about the PCBs in the paint following the sampling in May 2006.

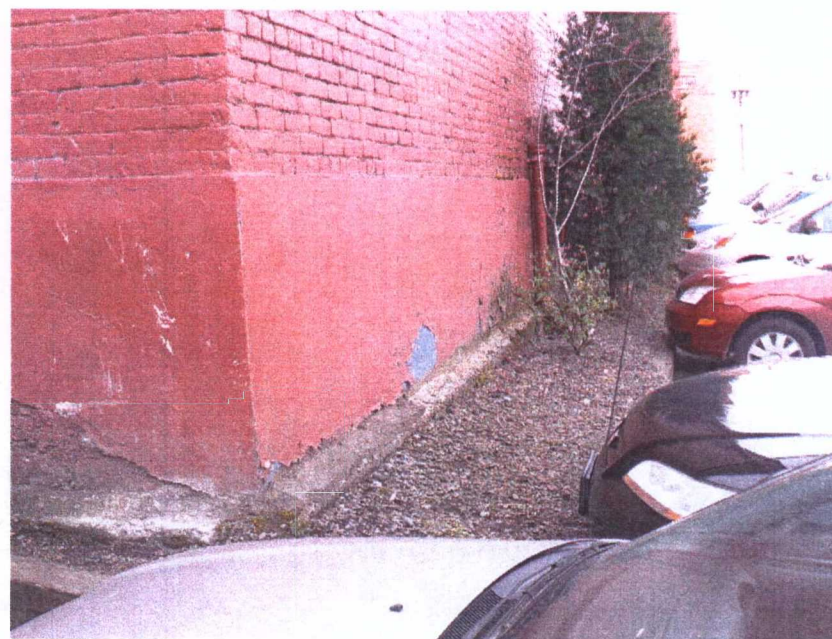
Description: The gravel strip in front of the west wall of Building 13 is covered with paint chips that have broken off the buildings surface. Rainier Commons' consultant suspected that during a rain event these paint chips migrate into the catch basins around the building. The west wall of Building 13 is up-hill to Catch Basin 3 and 2 (See Draft Catch Basin Plan).

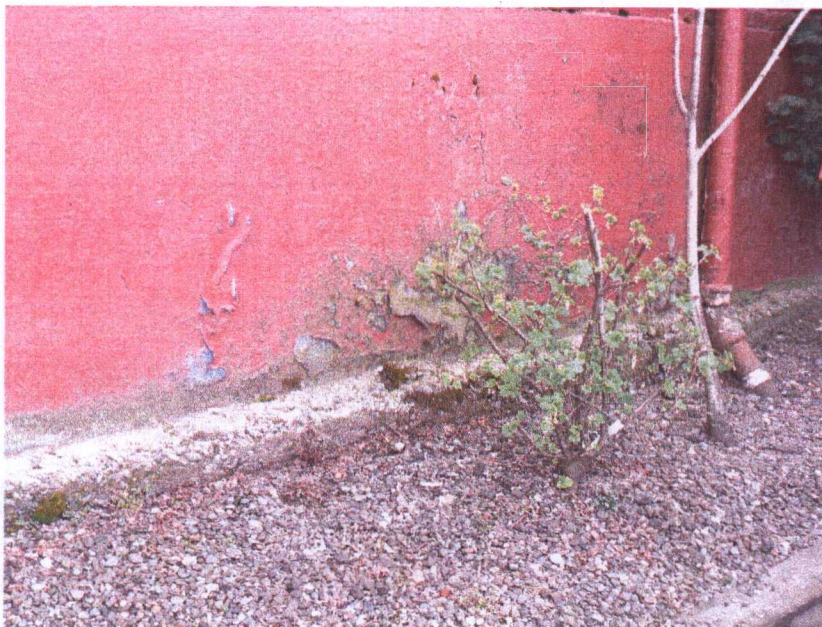
Photo No: P1000871

Description: The colorful reflection in the gravel strip is paint chips. EPA collected paint chips long the west wall of Building 13. EPA collected paint samples from the paint chips in the gravel strip and in the parking lot leading to the Catch Basins (Sample No. 09124302). The analysis shows PCBs greater than 2000 mg/kg.

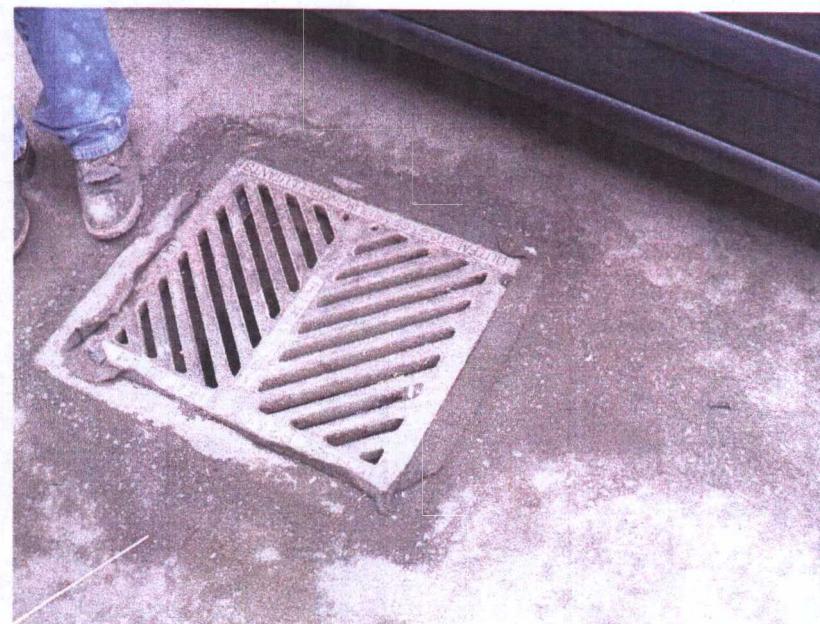
Description: This is a typical catch basin cover. In January 2009, Rainier Commons added silt socks to the catch basin. This sock is designed to collect sediment and paint chips that are picked up by the rain. There is a locking device on the metal cover. EPA was not able to unlock the cover for sample collection at this time of this inspection.

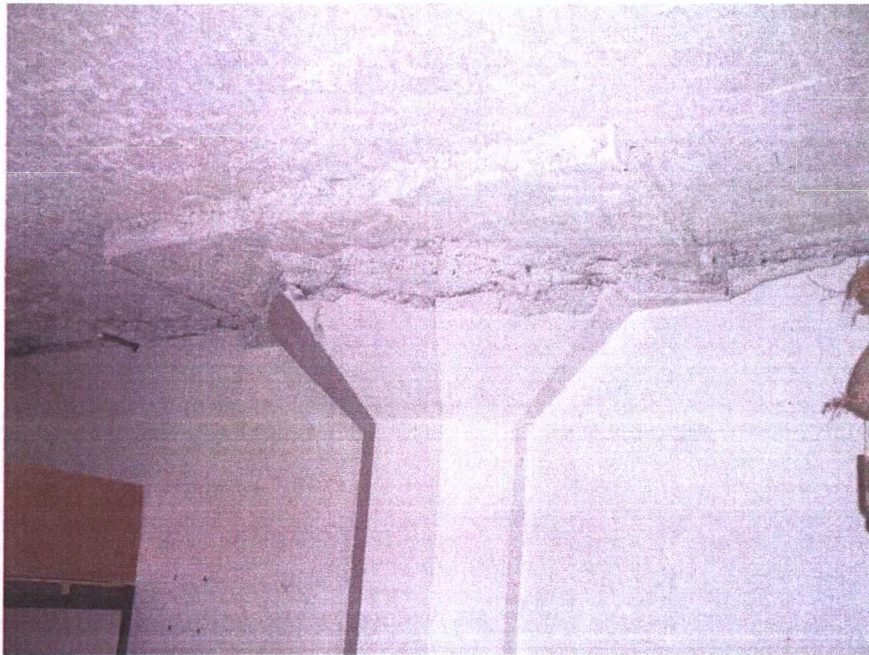
Photograph 11: Facing southeast; view of damaged concrete where support pillar meets ceiling on 1st floor of Building 14.

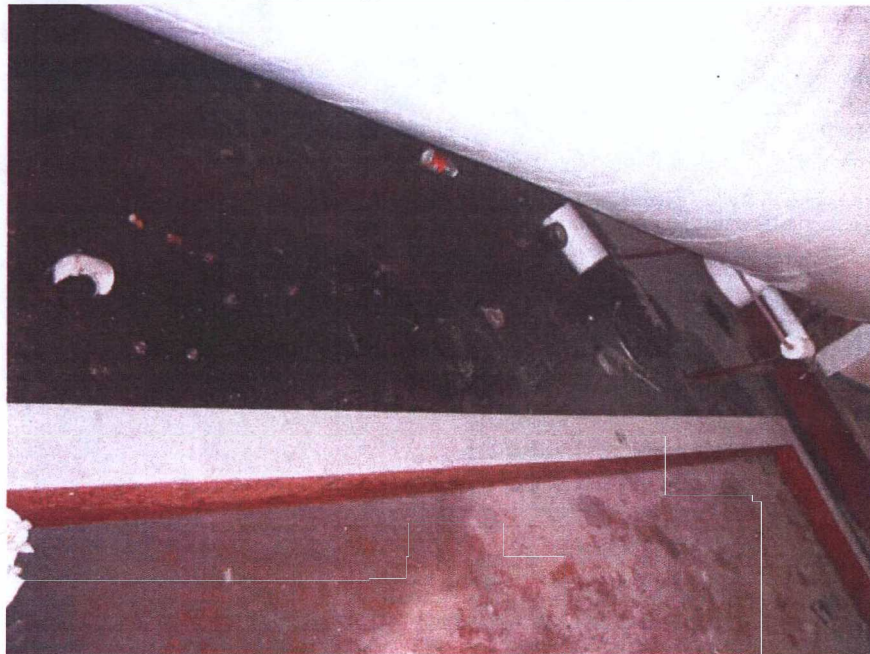
Photograph 12: Facing northeast; view of pooled oil beneath aboveground storage tank on 2nd floor of Building 14.

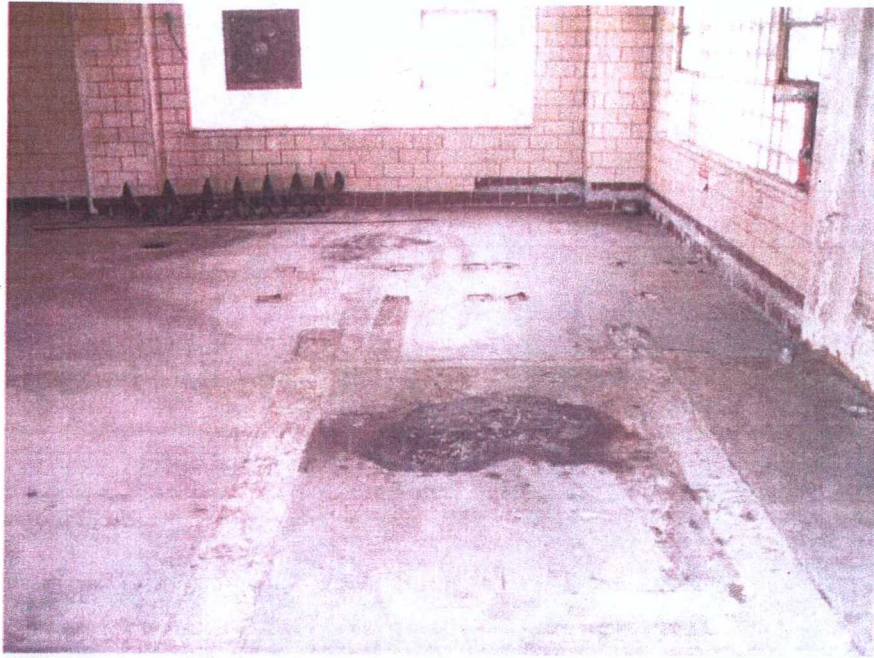
Photograph 17: Facing west; view of staining around drain on 6th floor of Building 21.

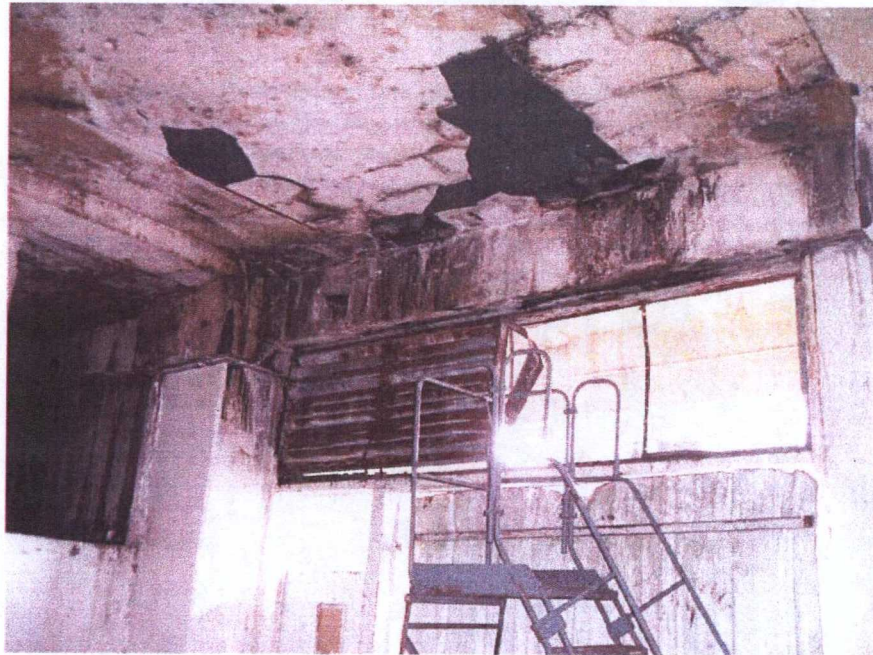
Photograph 18: Facing southeast; view of staining on wall, ceiling, and vent plenums on 2nd floor of Building 25, near rear exit.
